TECHNICAL SERVICE BULLETIN

VALVE BODY CHANGES IN KM170 SERIES TRANSAXLES

NO.	TSB-89-21-002
DATE	January, 1989
MODEL	Mirage, Galant

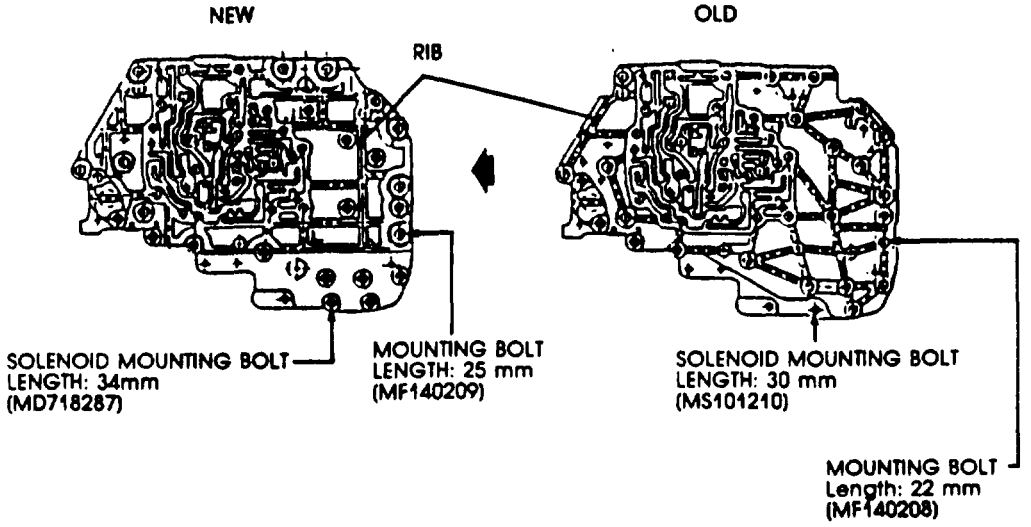
1. Intermediate Plate and Mounting Bolts
   On the KM175 transaxle the following changes have been made as shown:
   a. The intermediate plate ribs have been changed,
   b. The lengths of the valve body mounting bolts have been increased.
   c. The lengths of the solenoid valve mounting bolts have been increased.

New and old valve body and mounting bolts are interchangeable only as a set.

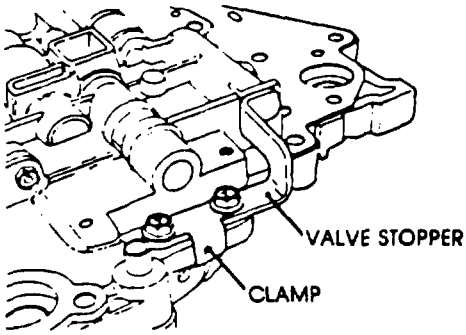
2. Wire Clamp
On the KM171 and KM175 the clamp used to route the so· ›id valve wires has been changed in shape.
